Rocky Mountain Village Estates
Evergreen, CO

Report #: 8361-5
Beginning: January 1, 2024
Expires: December 31, 2024

RESERVE STUDY
Update "With-Site-Visit"

October 25, 2023

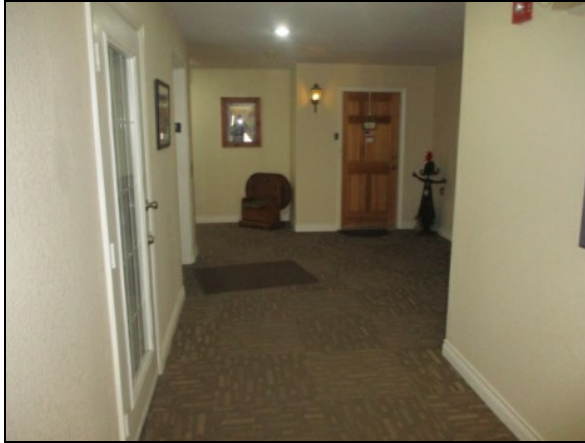
Comments: Includes 1st and Second Floors. Client reported that the interiors are painted annually. Regular cycles of professional painting are recommended to maintain appearance. Small touch-up projects can be conducted as needed as a maintenance expense, but comprehensive painting of interior areas will restore a consistent look and quality to all areas. Best practice is to coordinate at same time as other interior projects (flooring, furnishings, lighting, etc.) whenever possible to minimize downtime and maintain consistent quality standard.
