Rocky Mountain Village Estates
Evergreen, CO

Report #: 8361-5
Beginning: January 1, 2024
Expires: December 31, 2024

RESERVE STUDY
Update "With-Site-Visit"

October 25, 2023

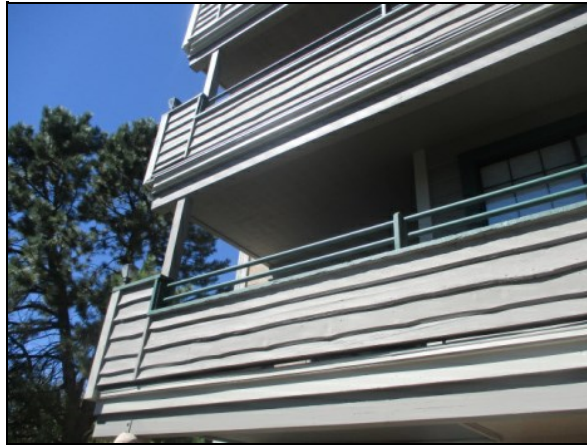
Comp #: 23310 Wood Exterior - Repair/Repaint

Comments: This component also covers the painting of the carpents. Painted exterior surfaces determined to be in fair condition typically exhibit some minor to moderate signs of wear and age such as chalking, peeling, blistering, etc. Problems tend to develop in more exposed areas first. Hairline cracks may be present at this stage. Overall appearance is satisfactory. As routine maintenance, inspect regularly (including sealants), repair locally and touch-up paint as needed. Typical paint cycles can vary greatly depending upon many factors including type of material painted, surface preparations, quality of material, application methods, weather conditions during application, moisture beneath paint, and exposure to weather conditions. Proper sealant/caulking is critical to preventing water intrusion and resulting damage to the building structure. Incorrect installations of sealant are common, and can greatly decrease its useful life. Inspect sealant, more frequently as it ages, to determine if it is failing. Typical sealant problems include failure of sealant to adhere to adjacent materials and tearing/splitting of the sealant itself. As sealants age and are exposure to ultra-violet sunlight, they will dry out, harden, and lose their elastic ability. Remove and replace sealant as signs of failure begin to appear. Proper cleaning, prep work, and proper installation are critical for a long lasting sealant/caulking. Do not install sealant in locations that would block water drainage from behind the siding. Repair areas as needed prior to project. For best results, the association may want to consult with a building envelope specialist or waterproofing contractor to specify types of materials to be used and define complete scope of work before bidding. Best practice is to coordinate this type of work with other projects whenever practical, such as balcony sealing, planter waterproofing, etc.

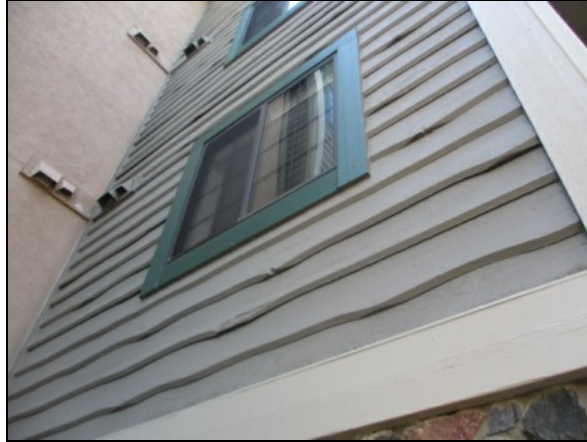
Comp #: 23320 Wood/Composite Siding - Replace

Comments: Wood siding determined to be in fair condition typically exhibits some color fading and inconsistency, with minor, isolated locations showing more advanced surface wear, cracking, splintering, etc. Composite siding is a compressed, glued wood fiber material. It is important to paint this type of siding regularly due to its ability to absorb water quickly when the surface is deteriorated or weathered. Once the composite siding takes on water the siding will swell and crack. At next replacement, association might want to consider replacing with more sturdy, lower-maintenance products. Although installation costs are higher, total life cycle cost is lower due to less maintenance and longer design life expectancy.

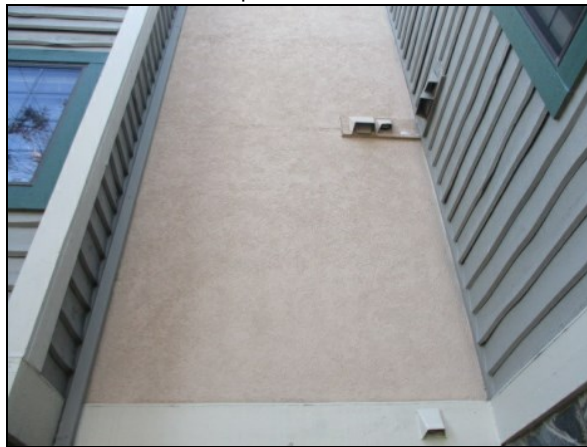
Comments: Painted exterior surfaces determined to be in good condition typically exhibit minimal signs of wear and age such as chalking, peeling, blistering, etc. Hairline cracks should not be present at this stage. Overall appearance is attractive. Stucco/EIFS is a relatively low maintenance material, although sealants require more maintenance. As annual maintenance, inspect stucco and sealants for any visible problems. Replacing sealants is an important part of maintaining stucco's waterproofing. Sealants are typically located at the intersections of the stucco and other material such as windows, door and vents. We have assumed the sealants are silicone, which under good conditions may have a useful life of approximately 15 to 20 years. Urethane sealants would have a useful life of 8-12 years. At time of sealant replacement we recommend recoating the stucco to minimize water penetration and for appearance. Stucco can be recoated to help limited the amount of water penetrating into the stucco. There are three general options for recoating stucco. The least expensive option is applying a new acrylic topcoat, the second option is coating with an elastomeric finish, preferably permeable (~50% more expensive than acrylic) and a third option is a skim coat of stucco (about three times as expensive as acrylic). Generally the more expensive option has the longest useful life, and the least expensive has the shortest useful life. Additional information on Stucco is available at the Portland Cement Association's website <http://www.cement.org/stucco/index.asp> Stucco is not an impermeable material and allows moisture to penetrate the surface, become captured by the water resistive barrier (WRB) beneath (typically Tyvek, felt or similar material), and either evaporate back through to the exterior or drain down and out the base of the wall assembly through a weep screed. Typically north facing sides will typically retain more moisture, which could cause a quicker rate of deterioration.

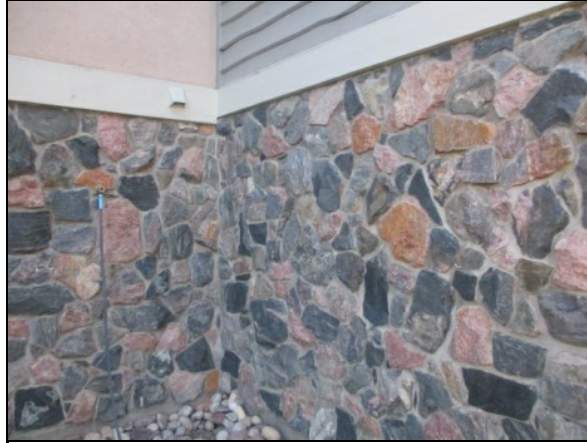
Comp #: 23370 Stone Veneer - Maintain/Repair

Comments: Brick or other masonry siding is typically a low maintenance surface that requires minimal, infrequent repair. However, in some cases (usually after several decades or more), the original mortar between bricks may require repointing to restore appearance and adequately protect against water intrusion. Repointing involves raking out a portion of the existing mortar and installing new mortar and continuing on until all affected sections have been replaced. In our experience, there is not a well-defined predictable timeline for repointing work, usually making this project inappropriate for Reserve funding. If re-pointing is a concern, we strongly recommend further inspection by a qualified engineer and/or masonry specialist to diagnose existing conditions and recommend a scope of work. If warranted, the Reserve Study can be adjusted to include funding recommendations going forward.

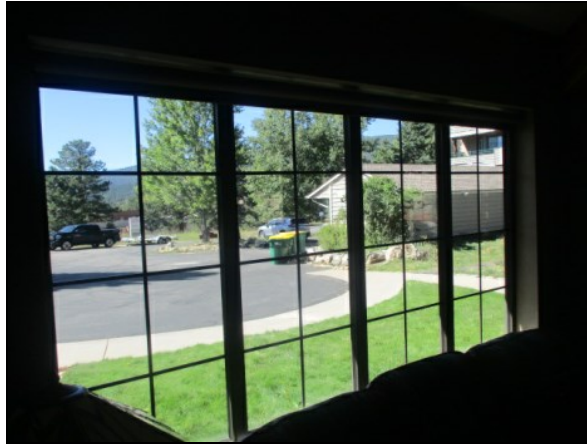
Comp #: 23440 Windows (Common) - Replace - 20%

Comments: Only includes common area windows in hallways and other common rooms. It was reported that the unit windows are the responsibility of the individual unit owner. Windows determined to be in fair condition typically exhibit normal signs of wear for their age, including more surface wear to framework and hardware, but no advanced corrosion or other concerns. At this stage, windows and doors are believed to be functional and aging normally, but more advanced technology may be available. Inspect regularly, including sealant, if any, and repair as needed. Proper sealant/caulking is critical to keeping water out of the walls, and preventing water damage. With ordinary care and maintenance, useful life is long but difficult to predict. Many factors affect useful life including quality of window installed, waterproofing flashing details, exposure to wind driven rain. In many cases, windows are replaced on an ongoing basis to select areas as-needed rather than to an entire building at one time. This component should be re-evaluated as the building ages and more problems develop, and funding recommendations should be adjusted accordingly. An allowance for partial replacements may be warranted if certain windows are more deteriorated than others. Consult with vendors to ensure replacement windows are compliant with all applicable building codes. Note there are many types of windows available in today's market and costs can vary greatly.

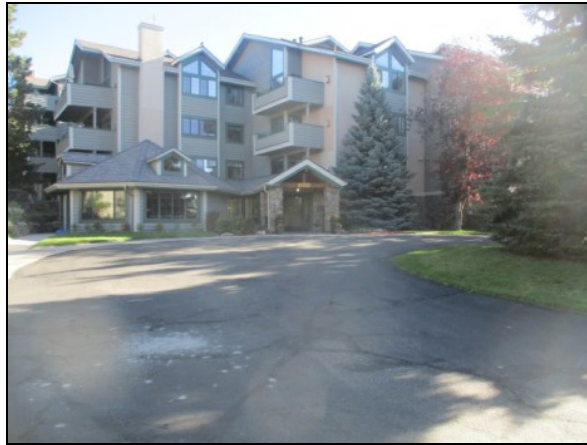
Comp #: 23570 Roof: Composition Shingle - Replace

Comments: Asphalt shingle roofs determined to be in fair condition and typically exhibit normal signs of wear and deterioration, including some loss of granule cover, and light to moderate curling/lifting, especially in most exposed areas. Overall believed to be aging normally. A reserve study conducts only a limited visual review, and many of the critical waterproofing and ventilation items of the roof are not readily viewable. For a full evaluation have a professional roof consultant/contractor perform a thorough up-close survey of your entire roof system, including attic inspection (if any). Costs below factors replacement with an architectural grade laminated shingle. As routine maintenance, many manufacturers recommend inspections at least twice annually (once in the fall before the snow season and again in the spring) and after large storm events. Promptly replace any damaged/missing sections or any other repair needed to ensure waterproof integrity of roof. Keep roof surface, gutters, and downspouts clear and free of debris. At the time of re-roofing, we recommend that you hire a professional consultant to evaluate the existing roof and specify the new roof materials/design, provide installation oversight. We recommend that all Associations hire qualified consultants whenever they are considering having work performed on any building envelope (waterproofing) components including: roof, walls, windows, decks, exterior painting, and caulking/sealant. There is a wealth of information available through Roofing Organizations such as: National Roofing Contractors Association (NRCA) <http://www.nrca.net>. Asphalt Roofing Manufacturers Association (ARMA) <http://www.asphaltroofing.org/> Roof Consultant Institute (RCI) <http://www.rci-online.org>

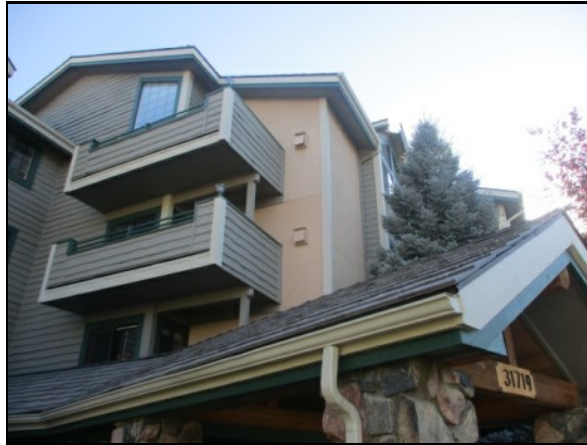
Comp #: 23650 Gutters/Downspouts - Replace

Comments: As routine maintenance, inspect regularly, keep gutters and downspouts free of debris. If buildings are located near trees, keep trees trimmed back to avoid accumulation of leaves on the roof surface which will accumulate in the gutters and increase maintenance requirements while reducing life expectancy. In general, costs related to this component are expected to be included in the Association's Operating budget. No recommendation for Reserve funding at this time. However, any repair and maintenance or other related expenditures should be tracked, and this component should be re-evaluated during future Reserve Study updates based on most recent information and data available at that time. If deemed appropriate for Reserve funding, component can be included in the funding plan at that time.

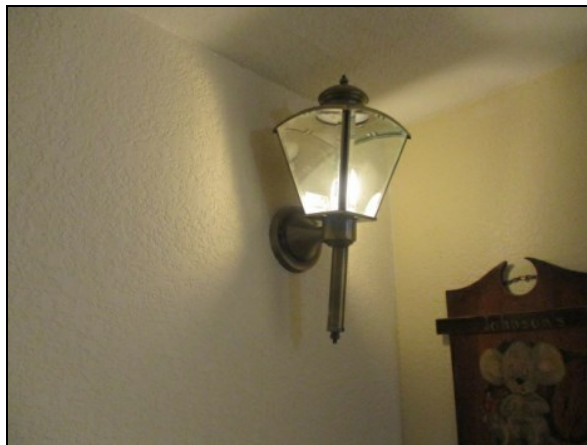
Comp #: 24030 Interior Lights - Replace

Comments: Interior wall lights were noted to be in fair condition with no significant damage/deterioration observed or reported to us. As routine maintenance, inspect, repair and change bulbs as needed. Best practice is to coordinate at same time as other interior projects (especially painting) whenever possible to minimize downtime and maintain consistent quality standard. Timing of replacements is ultimately subjective. Estimates shown here are based on our experience with similar properties and general aesthetic qualities. A wide variety of fixture styles is available funding recommendations are based on replacement with comparable quality fixtures.

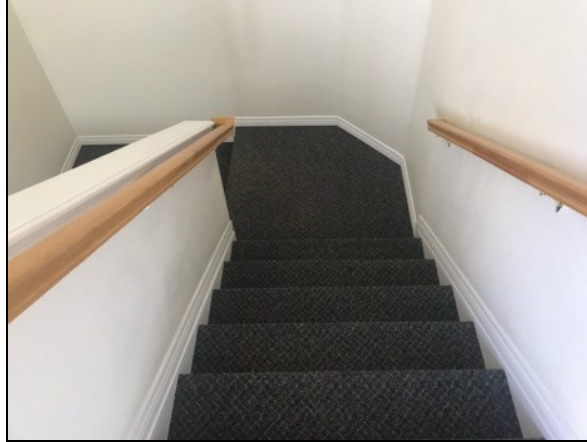
Comp #: 24040 Stairwell Carpet - Replace

Comments: Minor evidence of staining, matting, or loose seams observed. As part of ongoing maintenance program, vacuum regularly and professionally clean as needed. Best practice is to coordinate at same time as other interior projects whenever possible to minimize downtime and maintain consistent quality standard. Timing and interval is somewhat subjective, but not as flexible as other flooring finishes (tile, wood, etc.). Estimates shown here are based on our experience with similar properties and general aesthetic qualities. Schedule can be updated/adjusted at the discretion of the association for planning purposes.

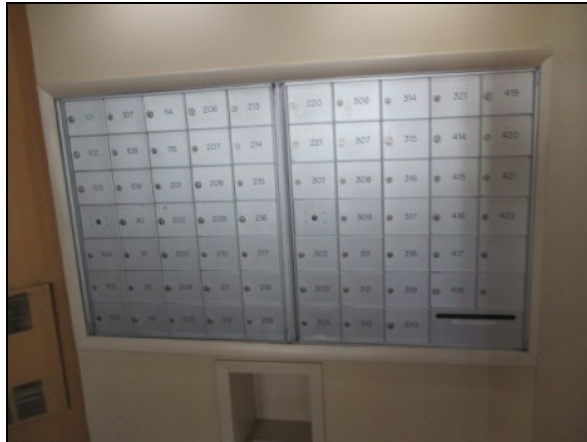
Comp #: 24060 Mailboxes - Replace

Comments: Mailboxes determined to be in fair condition typically exhibit some amount of surface wear and/or rusting, but remain in serviceable and generally decent aesthetic condition. Clean and inspect regularly, change lock cylinders, lubricate hinges and repair as needed from Operating budget. Metal mailbox structures located inside protected interior areas can have very long life expectancies. In our experience, it is prudent to expect replacement at the approximate interval shown below in order to maintain good appearance consistent with other interior areas. Timing of replacements is ultimately subjective.

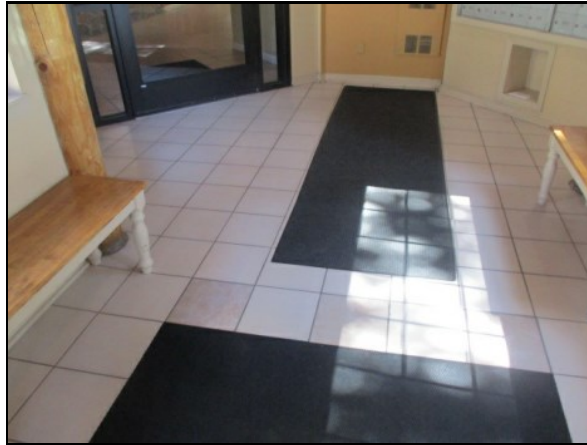
Comp #: 24070 Tile Flooring - Replace

Comments: Tiled surfaces were determined to be in fair condition. Floors did not exhibit any extensive un-even or broken sections. No evidence of heavy deterioration or broken tiles. As part of ongoing maintenance program, inspect regularly, repairing or replacing damaged sections as needed. If available, best practice is to keep a collection of replacement tiles on hand for partial replacements. With ordinary care and maintenance, tile in interior locations can last for an extended period of time, but replacement is often warranted eventually to enhance and restore aesthetic appeal in the common areas. Replacement costs can vary greatly depending on size and type of tiles selected. Our recommendation is to replace at the approximate schedule shown here, but this schedule can be adjusted at the association's discretion. "

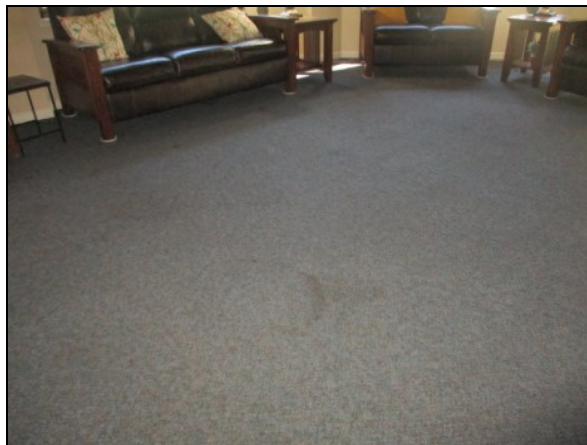
Comp #: 24080 Carpeting - Replace - 1&2

Comments: Carpeted surfaces were determined to be in poor condition. Evidence of staining, matting, and loose seams noted. Expect the need to replace the carpeting soon based upon the aesthetics of the building. As part of ongoing maintenance program, vacuum regularly and professionally clean as needed. Best practice is to coordinate at same time as other interior projects whenever possible to minimize downtime and maintain consistent quality standard. Timing and interval is somewhat subjective, but not as flexible as other flooring finishes (tile, wood, etc.). Estimates shown here are based on our experience with similar properties and general aesthetic qualities. Schedule can be updated/adjusted at the discretion of the client for planning purposes.

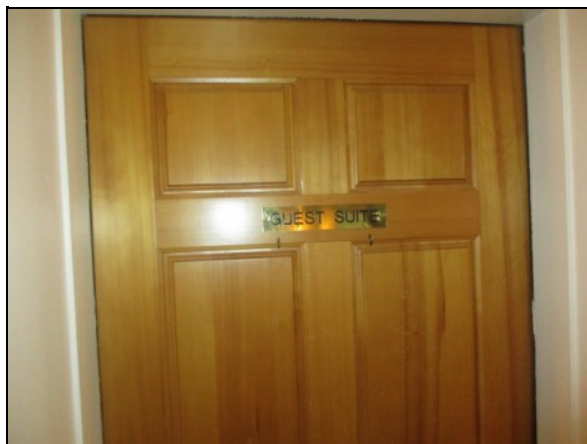
Comments: The guest suite was occupied at the time of inspection. No issues reported at the time of inspection. Room was believed to be in fair condition. Common rooms should be considered a significant aesthetic priority, even if use is minimal. Costs to remodel shown here may include replacement/restoration of flooring, interior painting, lighting, furnishings, decor, etc. Costs can vary greatly depending on overall scope of work and types of finishes/furnishings selected. Comprehensive updating should be anticipated at longer intervals to maintain a current, high-quality standard attractive to existing owners as well as potential buyers.

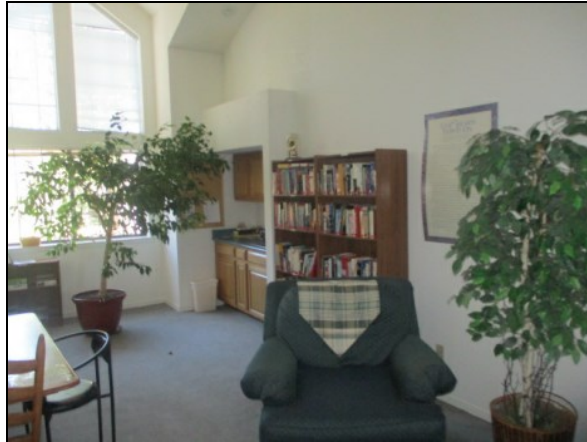
Comments: Includes 6 LF of base cabinet, 6 LF of wall cabinet, (1) sink, (4) book cases, (1) table, (4) chairs and (25) GSY of carpeting . Room was observed to be in fair condition. Flooring was mostly clean and free of any major issues. Fixtures appeared to be in good condition. Common rooms should be considered a significant aesthetic priority, even if use is minimal. Costs to remodel shown here may include replacement/restoration of flooring, interior painting, lighting, furnishings, decor, etc. Costs can vary greatly depending on overall scope of work and types of finishes/furnishings selected. Comprehensive updating should be anticipated at longer intervals to maintain a current, high-quality standard attractive to existing owners as well as potential buyers.

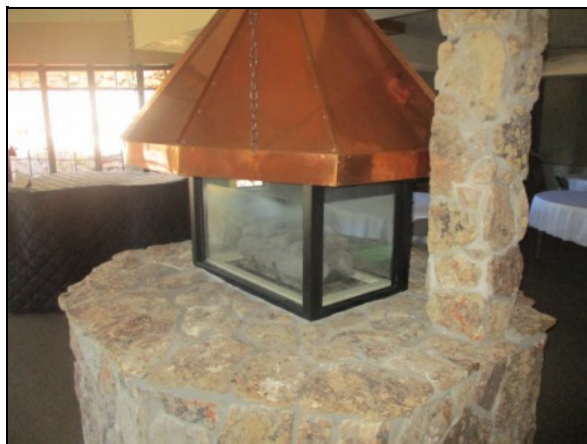
Comp #: 24350 Fireplace - Replace

Comments: Fireplaces should be inspected and evaluated regularly by servicing vendor. In some cases, replacement is warranted due to lack of available replacement parts, or to upgrade to more efficient technology. Treat routine repairs/maintenance as an Operating expense. Plan for replacement at the typical service life expectancy indicated below. Useful life can often be extended with proactive service and maintenance. Unless otherwise noted, funding for system with same size/capacity as the current system.

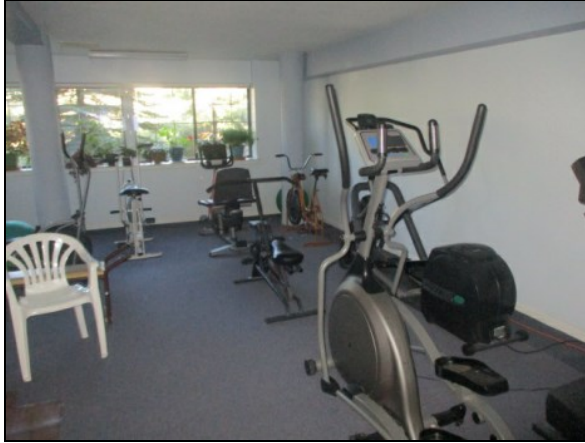
Comp #: 24360 Fitness Equipment - Replace

Comments: It was reported that the fitness equipment has been donated over the years by the residents. There is no plan to assume responsibility of the fitness equipment. No recommendation for Reserve funding at this time.

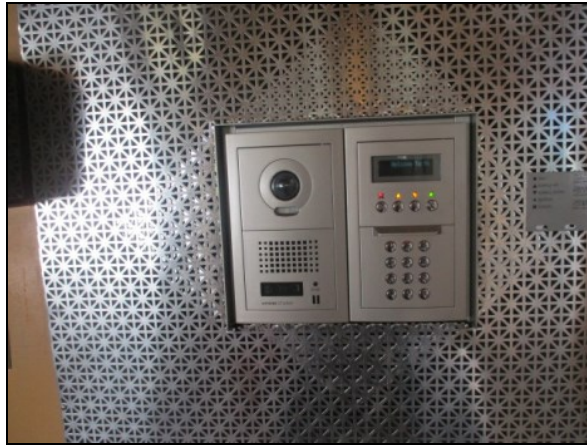
Comp #: 25010 Intercom/Entry System - Replace

History: Replaced in 2015

Comments: Previous work on this component included substantial rewiring to update outdated system. Funding going forward is expected to only include the entry box itself. Access/intercom system was not inspected internally during site inspection. Should be checked and repaired as needed by servicing vendor as routine maintenance. Individual components can often be replaced for relatively low cost as an Operating expense. Plan for complete replacement at the approximate interval shown here for functional and aesthetic considerations.

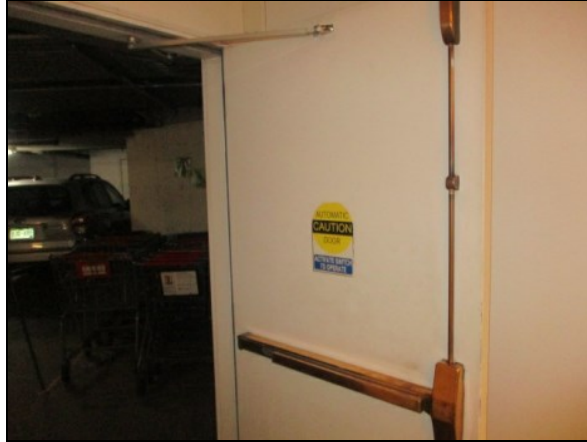
Comp #: 25050 Automatic Doors - Replace

Comments: (Minimal or no subjective/aesthetic value for this component. Useful life is based primarily on normal expectations for service/performance life in this location. Unless otherwise noted, remaining useful life expectancy is based primarily on original installation or last replacement/purchase date, our experience with similar systems/components, and assuming normal amount of usage and good preventive maintenance. Plan to replace at the approximate interval shown here due to use, exposure, and advancements in technology. Should be inspected regularly as an Operating/maintenance expense to ensure proper function. Clean frequently and repair promptly when needed to maintain good appearance.

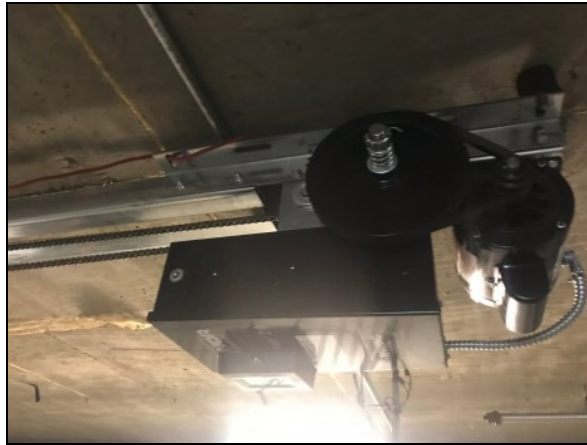
Comp #: 25060 Gate Operators - Replace

History: Replaced in 2016

Comments: Raynor control hoist 2.0 model CST211SS serial # 2685344 1/2 hp. Minimal or no subjective/aesthetic value for this component. Useful life is based primarily on normal expectations for service/performance life in this location. Unless otherwise noted, remaining useful life expectancy is based primarily on original installation or last replacement/purchase date, our experience with similar systems/components, and assuming normal amount of usage and good preventive maintenance. We recommend regular inspections (including service and repair as needed) be paid through the Operating budget. Monitor actual expenses closely for future Reserve Study updates. In general, costs related to this component are expected to be included in the Association's Operating budget. No recommendation for Reserve funding at this time. However, any repair and maintenance or other related expenditures should be tracked, and this component should be re-evaluated during future Reserve Study updates based on most recent information and data available at that time. If deemed appropriate for Reserve funding, component can be included in the funding plan at that time.

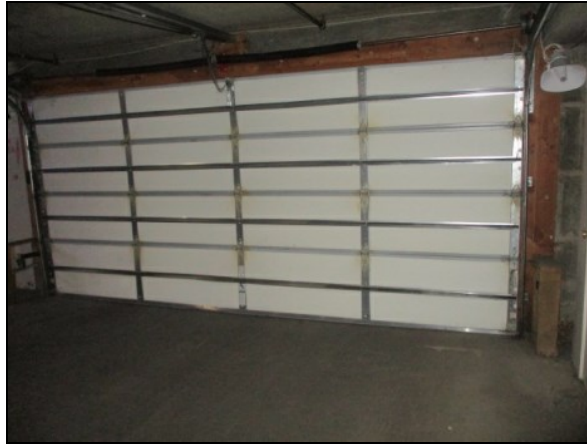
Comp #: 25070 Garage Door - Replace

Comments: We strongly recommend regular inspections, maintenance and repairs to help extend useful life cycles. Clean for appearance and paint/touch-up as needed as a general maintenance expense. In general, costs related to replacement of this component are expected to be included in the Association's Operating budget. No recommendation for Reserve funding at this time. However, any repair and maintenance or other related expenditures should be tracked, and this component should be re-evaluated during future Reserve Study updates based on most recent information and data available at that time. If deemed appropriate for Reserve funding, component can be included in the funding plan at that time.

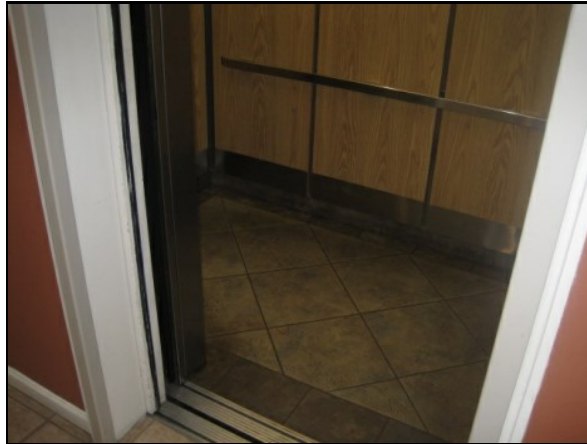
Comments: Elevator cabs determined to be in fair condition typically exhibit normal signs of wear and age, such as scuffing and surface wear to flooring and wall paneling, but remain generally clean and without any signs of advanced wear or damage. At this stage, aesthetic standards are still being upheld and cabs are aging normally overall. This component recommends budgeting for periodic remodeling of the elevator cab interior(s) to ensure good physical condition and maintain aesthetic standards of the property. Timing of this elective project is ultimately at the discretion of the client, but ideally should be coordinated with mechanical modernization to minimize downtime. Cost can vary greatly depending upon chosen design, and our estimates assume remodeling to a similar standard as currently in place. If higher quality standards are being considered, increases may need to be incorporated into future updates. A general allowance based upon our experience and consultation with elevator vendors is shown below for budgeting purposes, but any new information or cost estimates should be incorporated into future Reserve Study updates when known. Note if present, any service-only cabs are not expected to be a significant aesthetic priority and are not included here unless otherwise noted.

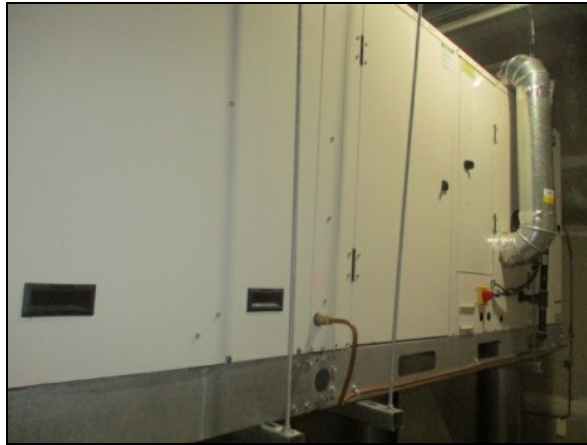
Comp #: 25210 AHU Furnace - Replace

History: Replaced in 2018

Comments: Reznor model HXE250-6-SMVJ serial #EARK66KIN59926MV4. Minimal or no subjective/aesthetic value for this component. Useful life is based primarily on normal expectations for service/performance life in this location. Unless otherwise noted, remaining useful life expectancy is based primarily on original installation or last replacement/purchase date, our experience with similar systems/components, and assuming normal amount of usage and good preventive maintenance. We recommend that routine repairs and maintenance such as filter replacements, system flushing, etc. be budgeted as an Operating expense. Useful life can often be extended with proactive service and maintenance. Unless otherwise noted, funding for system with same size/capacity as the current system. For split systems, we recommend budgeting to replace the entire system (condensing unit and air handler) together in order to obtain better unit pricing and ensure maximum efficiency, refrigerant compatibility, etc. If additional costs are expected during replacement, such as for system reconfiguration or expansion, ductwork repairs, electrical work, etc. costs should be re-evaluated and adjusted as needed during future Reserve Study updates.

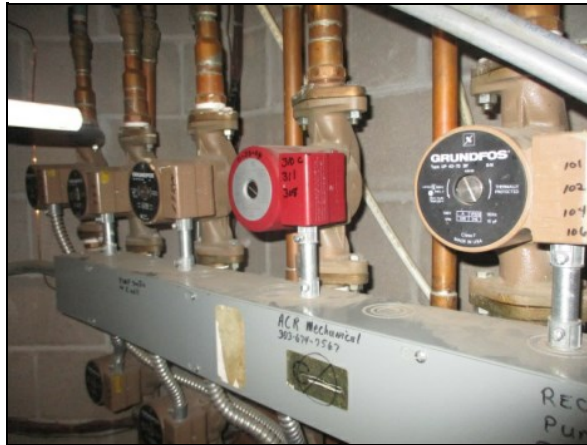
Comp #: 25280 Pumps/Motors - Repair/Replace - Sm.

History: Replaced in 2018

Comments: Includes (24) small Grundfos pumps. Expect eventual need for tear down and rebuild (more cost-effective than buying new units) at roughly the interval below. Treat smaller repair / replacement below the reserve funding threshold (< 1% of the annual operating expenses, excluding reserves) as general maintenance item(s) within operating budget.

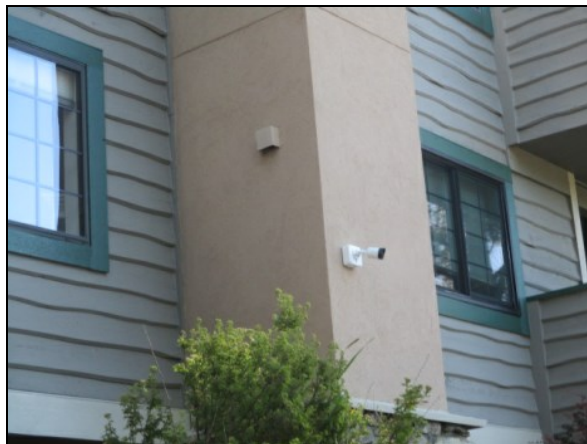
Comp #: 25330 Surveillance System-Upgrade/Replace

Comments: Minimal or no subjective/aesthetic value for this component. Useful life is based primarily on normal expectations for service/performance life in this location. Unless otherwise noted, remaining useful life expectancy is based primarily on original installation or last replacement/purchase date, our experience with similar systems/components, and assuming normal amount of usage and good preventive maintenance. Security/surveillance systems should be monitored closely to ensure proper function. Whenever possible, camera locations should be protected and isolated to prevent tampering and/or theft. Typical modernization projects may include addition and/or replacement of cameras, recording equipment, monitors, software, etc. Unless otherwise noted, costs assume that existing wiring can be re-used and only the actual cameras and other equipment will be replaced. In many cases, replacement or modernization is warranted due to advancement in technology, not necessarily due to functional failure of the existing system. Keep track of any partial replacements and include cost history during future Reserve Study updates.

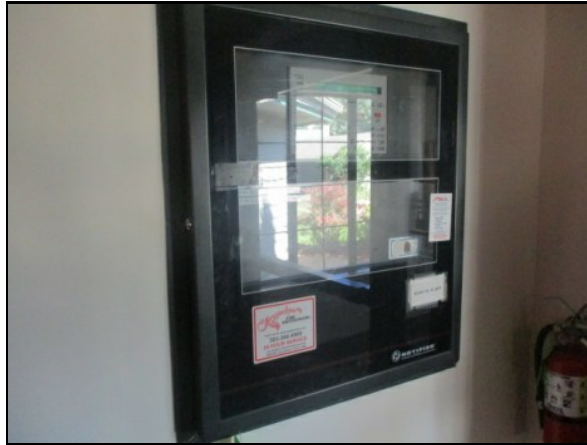
Comp #: 25410 Fire Control Panel - Update/Replace

Comments: Panel is a Fire-Lite model. Our inspection is for planning and budgeting purposes only fire alarm equipment is assumed to have been designed and installed properly and is assumed to comply with all relevant building codes. Regular testing and inspections should be conducted as an Operating expense. In many cases, manufacturers discontinue support of equipment after a certain number of years, which may limit availability of replacement parts as the system ages. Cost estimates assume that existing wiring can be re-used and that only panel and devices will be replaced. If wiring requires replacement, estimates should be increased accordingly, but in our experience wiring should have an indefinite useful life. Cost estimates are based on quantity and type of existing equipment, not including any expansion or upgrades, which may be required. We recommend reviewing system components with fire alarm vendor on a regular basis. If expansion of system is found to be required, the Reserve Study should be updated and any additional costs should be factored accordingly.

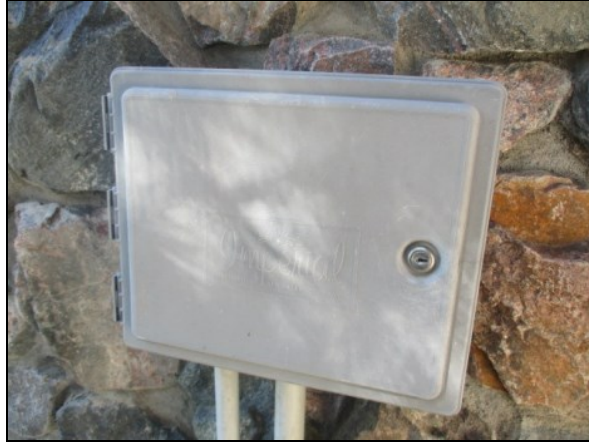
Comp #: 25570 Irrigation Clocks - Replace

Comments: In general, costs related to this component are expected to be included in the client's Operating budget. No recommendation for Reserve funding at this time. However, any repair and maintenance or other related expenditures should be tracked, and this component should be re-evaluated during future Reserve Study updates based on most recent information and data available at that time. If deemed appropriate for Reserve funding, component can be included in the funding plan at that time.
